## **Slope Stability of the Middle Eocene Rocks of Gebel Mokattam**

*Mahmoud S.M. Yousif Department of Geology,  
Faculty of Science, Ain Shams University*

**Abstract-** The middle plateau of G. Mokattam is made up of hard limestone rocks of Middle Eocene age. The slopes of these rocks, however, show the effect of man-made activities, especially past-quarrying. For this reason, these slopes are very steep and form sheer scarps in several places. In addition, large natural caves also exist near the top of the Middle Eocene rocks of G. Mokattam as well as the area south of G. Mokattam to the east of Maadi and Helwan.

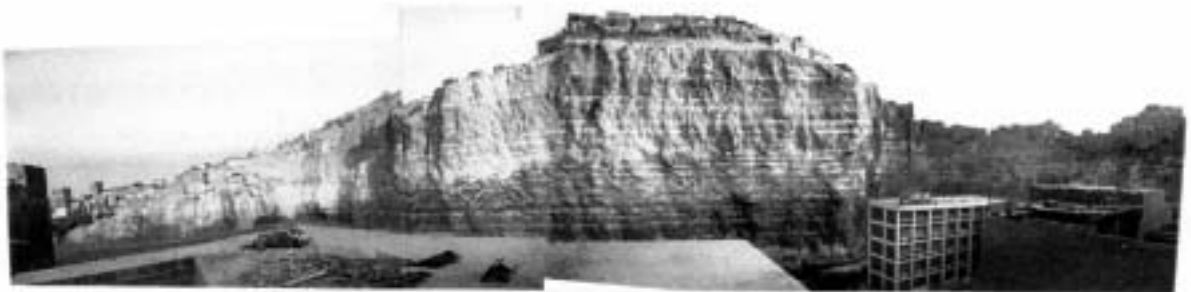
**Fig. 2**

Fig. 2: Field panorama (looking due east) showing random urban expansion of Manshiet Naser area where houses are built both on top of the middle plateau and close to the scarps of old quarries on the sides of G. Mokattam.

Gebel Mokattam is located east of Cairo and is bounded on the north by Gebel Ahmer, on the east by a gently sloping desert area leading to the New Cairo city, on the south by the Greater Cairo ring road, and on the west by the autostrade and Salah Salem road. Gebel Mokattam is a topographically high area that has a relief equal to about 160 meters. It includes two main flat-topped areas locally referred to as the middle and upper plateaus. Mokattam city was built on the upper plateau whereas the middle plateau is the site of a large housing project that started in the 1980's and has not been completed so far. The topographically low areas surrounding G. Mokattam, especially on the west and south are areas of large urban expansion in a relatively very short period of time (Fig. 1). Manshiet Naser and El Doweika are two of these highly populated areas with randomly built houses (urban sprawl) on the topographically low area abutting G. Mokattam on the west and north respectively (Fig. 2). Old cemetery as well as the Abajia houses are located on the southern side of G. Mokattam.

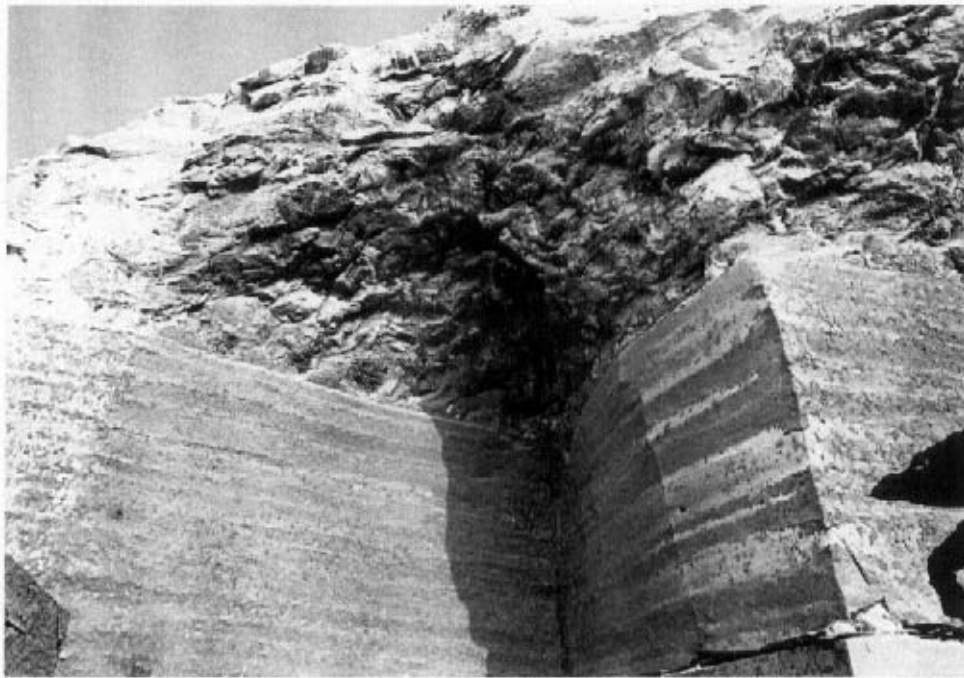
**Fig. 7**

Almost all the slopes of the Middle Eocene rocks of G. Mokattam are man-made slopes formed due to the past quarrying activities. Vertical smooth slopes characterize the area east of the Citadel reflecting saw-type quarrying. At Manshiet Naser, some of the stair-case slopes are also formed by saw-type quarrying (Fig. 7). On the other hand, nearly vertical and rough slopes characterize the Middle Eocene outcrops extending from Abajia to the southern side of G. Mokattam and seem to have been formed by mild explosion-type quarrying.

Fig. 7: Field photograph of quarry walls in Manshiet Naser. Notice the smooth vertical slopes in the lower part of the photograph due to saw-type quarrying activities and the rough slope at the top of the exposure due to normal or explosion-type quarrying.

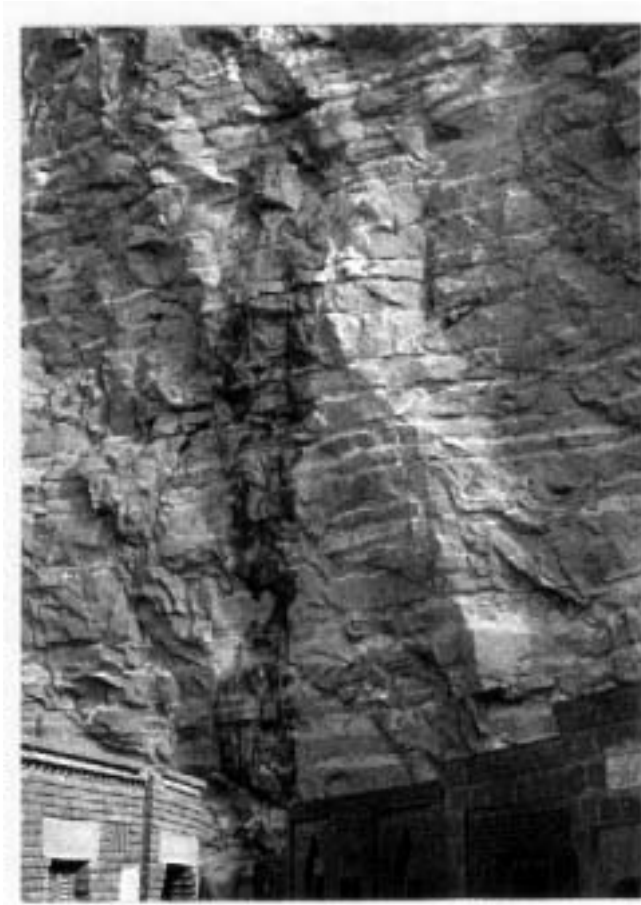
**Fig. 9**

d-Increase in pore water pressure of rocks which happens when the rocks are continuously soaked with water in vicinity of joint surfaces. This phenomenon is common in G. Mokattam area such as the slopes north of the Abajia cemetery east of where surface water is leaking from the top of the middle plateau through the jointed Middle Eocene rocks (Fig. 9). The same phenomenon is also taking place at the Samaan church at Manshiet Naser where the church was built on top of a terrace in the western scarp of G. Mokattam. Activities in the church include cultivation and gardening work which leak some water through the limestone beds underlying the church and forming the lower scarp of this area.

Fig. 9: Leaking water through the limestone beds on the southern scarp of G. Mokattam at the cemetery east of Abajia. Water leaks through the fractures in the limestone beds and comes from water discharged due to human activities on top of the middle plateau.

1. Avoiding any leakage of water (sewage water, drinking water from water pipes, gardening water,... etc.) from the top of the plateaus of G. Mokattam into the Middle Eocene rocks. In severe cases of highly water-saturated Middle Eocene rocks, some shallow wells may be drilled from the top of the middle plateau through these areas in order to drain such water and decrease the pore-water pressure.

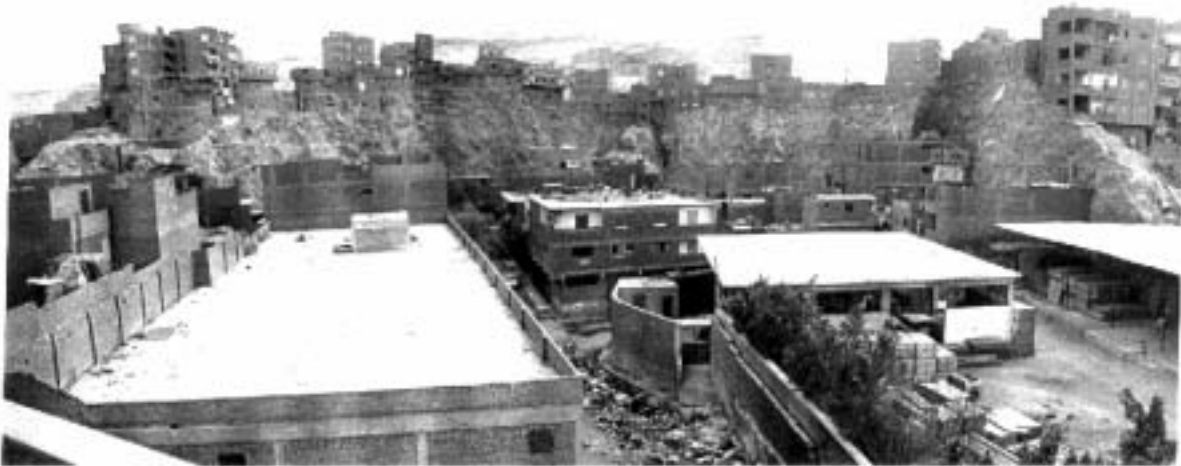
**Fig.14**

Fig. 14: Old crescent-shaped limestone quarry at Manshiet Naser. This quarry was used later as a construction site and houses are built close to the side ridges of the quarry. Any slope failure that may happen in this area (especially in the side ridges) may lead to serious loss of life and property.

2. Terminating all proposed housing and construction works in vicinity of old quarry walls.

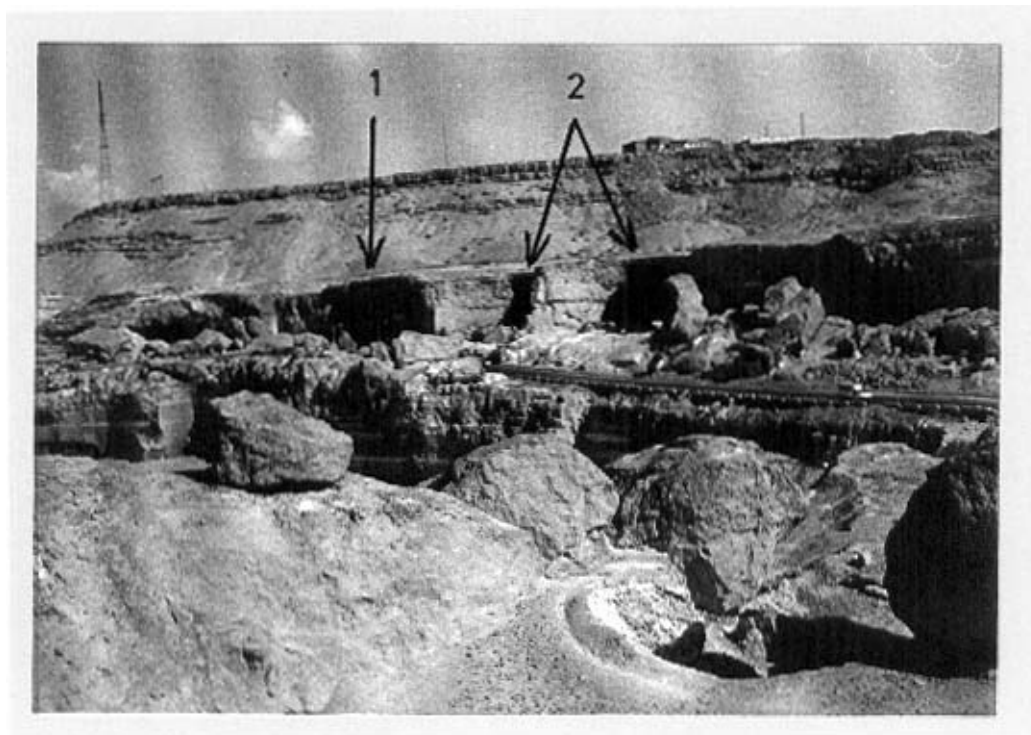
**Fig.17**

Five main caves are found in the Middle Eocene rocks on both sides of the Mokattam city road (Fig. 16). These caves occupy the uppermost part of the Middle Eocene section (Fig. 17). The walls of these caves seem to have been trimmed by humans likely when these caves were used for military purposes during the British occupation of the country. The walls were trimmed to attain convex upward profiles in order to distribute the stress resulting from the overburden and also to allow larger area in the lower part of each cave. The floors of these caves are covered by soft dusty material resulting from the erosion of the limestone rocks of the cave walls and ceiling.

Fig. 17: Field photograph of caves number 1 and 2 shown in Fig. 16. These caves are located in the uppermost part of the Middle Eocene section.

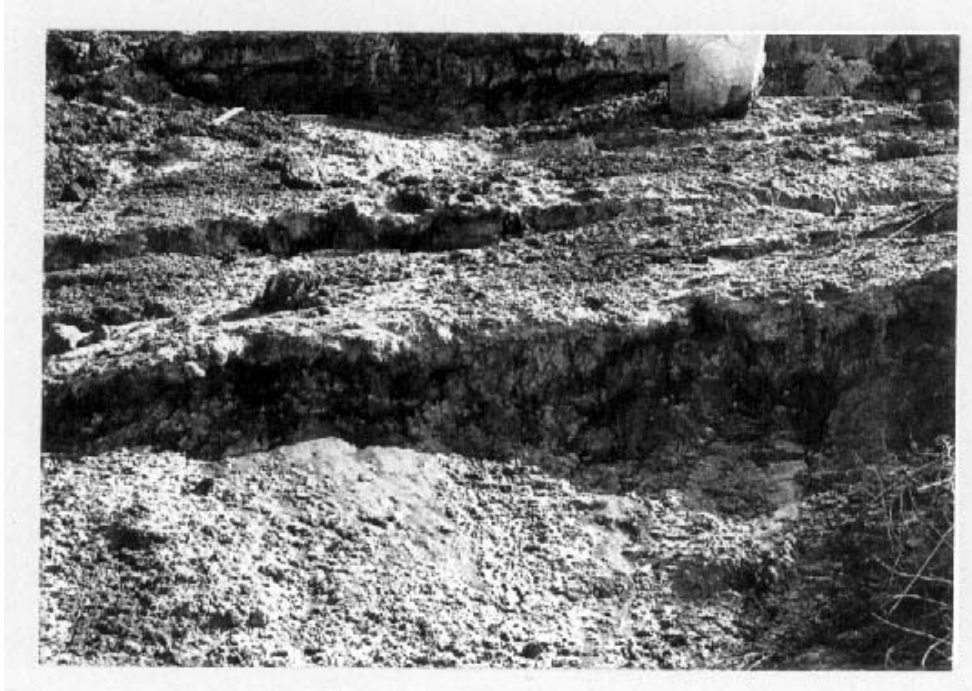
**Fig.18**

Water was leaking from the ceiling of cave number 2 forming a continuous, shower-like flow. Detailed inspection of the area overlying this cave indicated that the leaking water comes from a sewage pipe that passes above the cave and leaks most of its water in this area. Running sewage water is obvious on the slopes of the Upper Eocene rocks above the cave (Fig. 18). Large salt deposits are located on the same slopes due to evaporation of some of the leaking water. Also, abundant flourishing of brown, green, and orange algae characterize this wet area. Leaking sewage water infiltrates through the joint surfaces into the cave and forms shower-like drainage at the intersection of the joint surfaces with the ceiling of the cave. Most of the joint surfaces dissecting the walls of this cave also have calcareous sinter

Field work during another field season (six months later) indicated that leaking water stopped in the cave due to the abandonment of the old sewage pipe. It was also obvious that a very large block collapsed from the ceiling of the cave between the two field seasons. The collapsed block is about 25 meters long, 6 meters wide, and 1-2 meters thick. It was separated from the rest of the ceiling along joint surfaces and bedding planes. The collapsed block probably fell down under the effect of increased weight due to saturation of the limestone by water as well as due to the decrease in shear resistance of the rock due to increased pore water pressure during water leakage.

Fig. 18: Leaking sewage water on the slopes of the Upper Eocene rocks overlying caves number 1 and 2 of G. Mokattam.
